U.S. Army Research, Development and Engineering Command

Galvanic Corrosion Study on SS Cartridge Design

5 February 2009

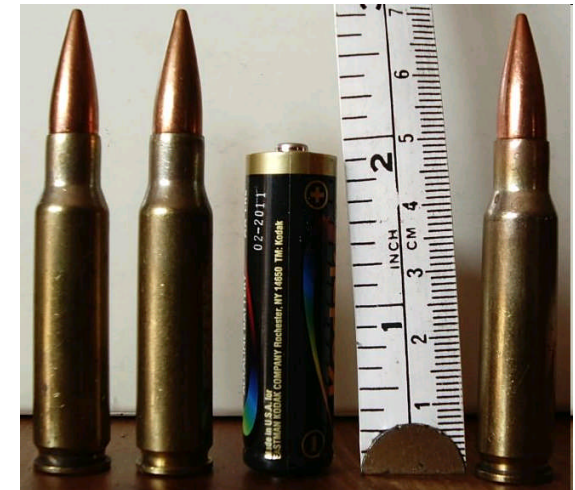
- Lightweight Cartridge for Small Arms program at Picatinny
 - Designing/developing stainless steel cartridge case
 - For structural support inserting Al plug
- Galvanic corrosion
 - Dissimilar metals that are in electrical contact while immersed in a solution electrolyte¹
- 3 main galvanic couples of concern shown below:

1.	Plug Insert 7075 T6 Aluminum	Cartridge Case 305 Stainless Steel
2.	Bullet Jacket Cu Alloy 220	Cartridge Case 305 Stainless Steel
3.	Cartridge Links 1045 Carbon Steel	Cartridge Case 305 Stainless Steel

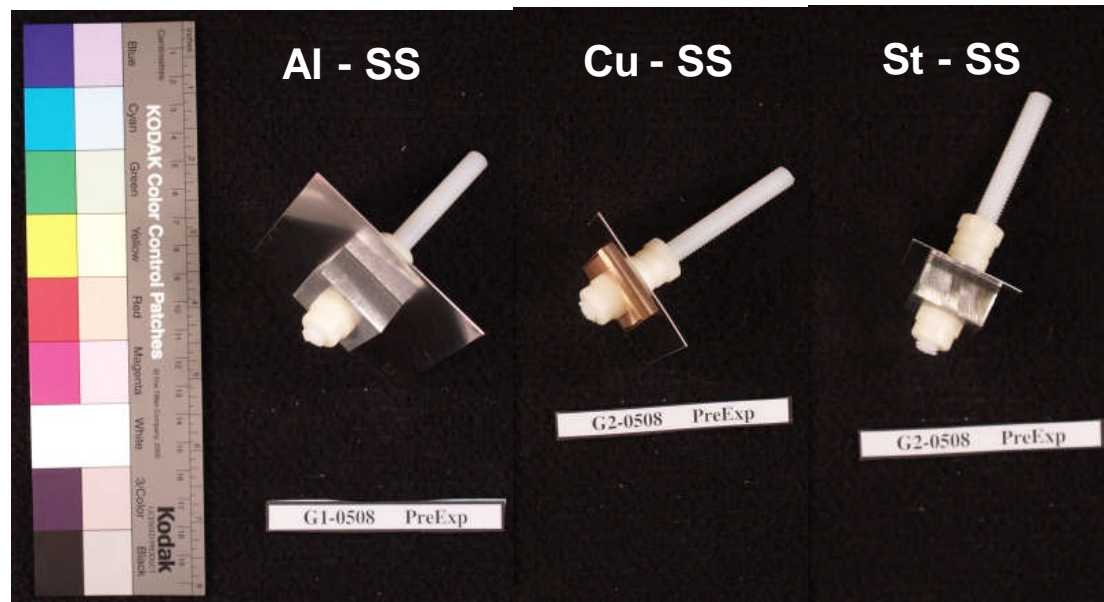
- Area ratio calculation (based on “ASTM G71”²)
 - SS cartridge to aluminum insert = **5 to 1**
 - SS cartridge to copper jacket = **4 to 1**
 - SS cartridge to steel links = **1 to 1**
- Small pieces of each material were cut, drilled, polished and cleaned
- Each couple was assembled using a nylon threaded rod and bolts

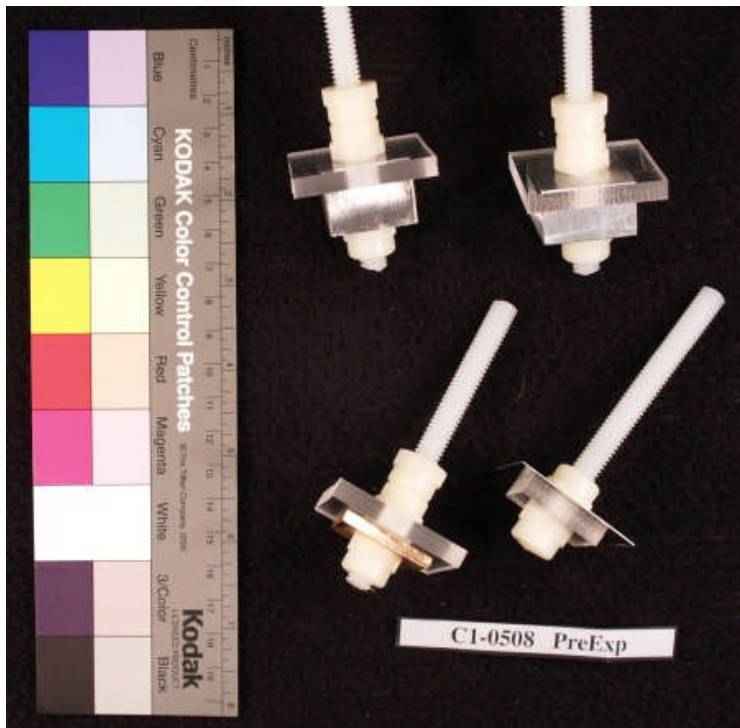
Specimens with plastic backing

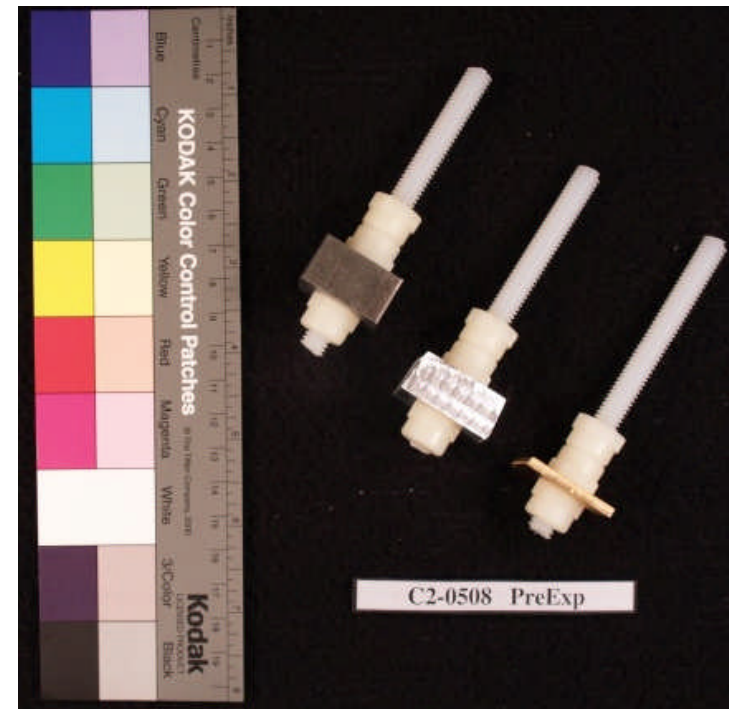
Specimens without plastic backing

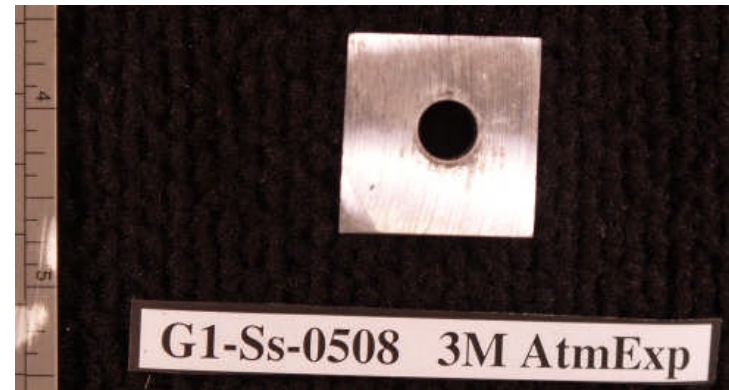
Slight discoloration on Al backside that was mated with the stainless steel

- No significant difference was visible between the Al-SS coupled and uncoupled materials after 3 months of exposure.
- This was expected because both Al and stainless steel form strong passive oxide layers in the presence of oxygen in the atmosphere.
- Only slight discoloration on the Al was noticed on the face that was mated with the stainless steel.

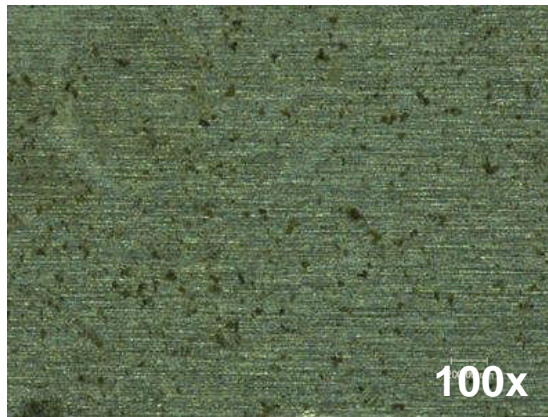
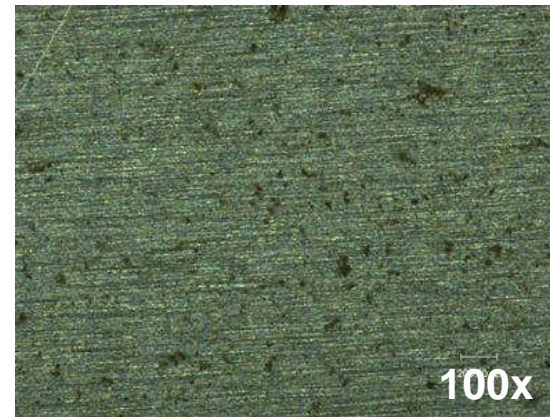
Pitting of stainless steel in crevice formed from (a) galvanic couple with Al and (b) plastic backing.

- The 305 stainless steel may be slightly vulnerable to pitting in any crevice conditions and should therefore be monitored.
- Materials and environments used in this study were chosen to represent the new cartridge design but surface treatments, manufacturing processes, actual environments, etc. can lead to unique results.
- Continued atmospheric exposure of several galvanic couples is underway. Any new pertinent information found upon further analysis will be reported.

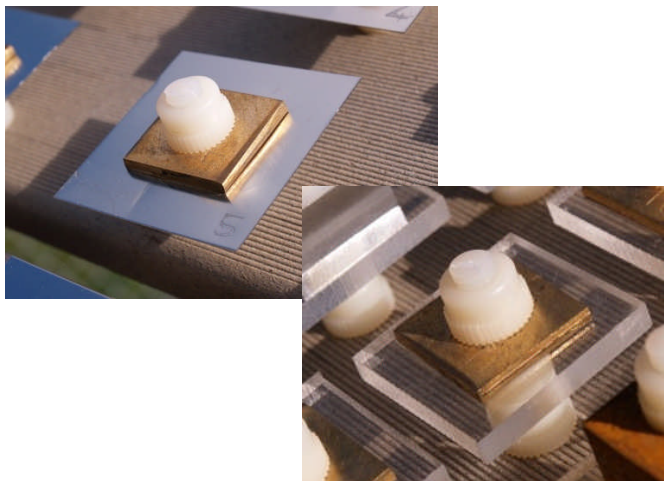
Slight tarnish on surfaces after 1 month of exposure

- As in the case of the Al-SS couples, the Cu alloy-SS materials did not corrode significantly different when coupled vs. uncoupled.
- The corrosion on the backside of the galvanic couple specimen was more evident than that of the plastic-backed specimen. The crevice formed in both setups appears to have contributed to the degradation but the galvanic couple provided a stronger driving force.
- The stainless steel specimens (both coupled to the Cu alloy and the plastic) exhibited pitting from the crevice formed.

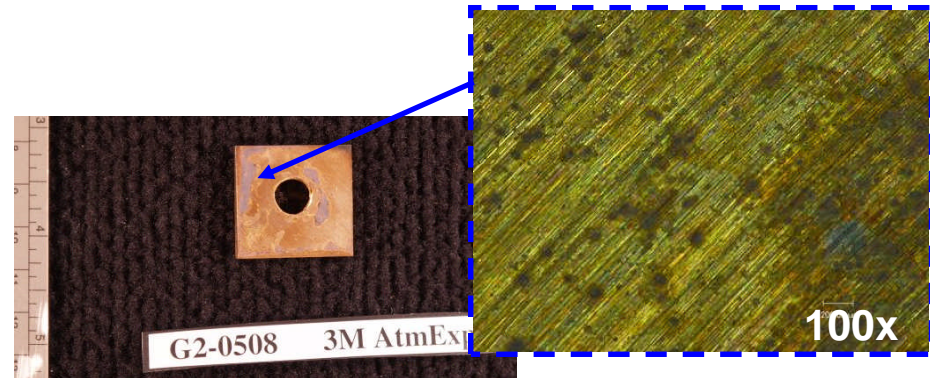
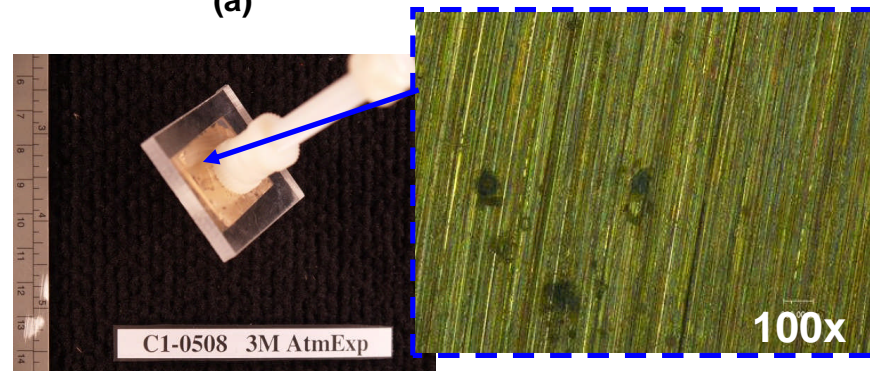
After 3 months atmospheric exposure on Cu alloy (a) face coupled to SS and (b) face coupled to plastic backing.

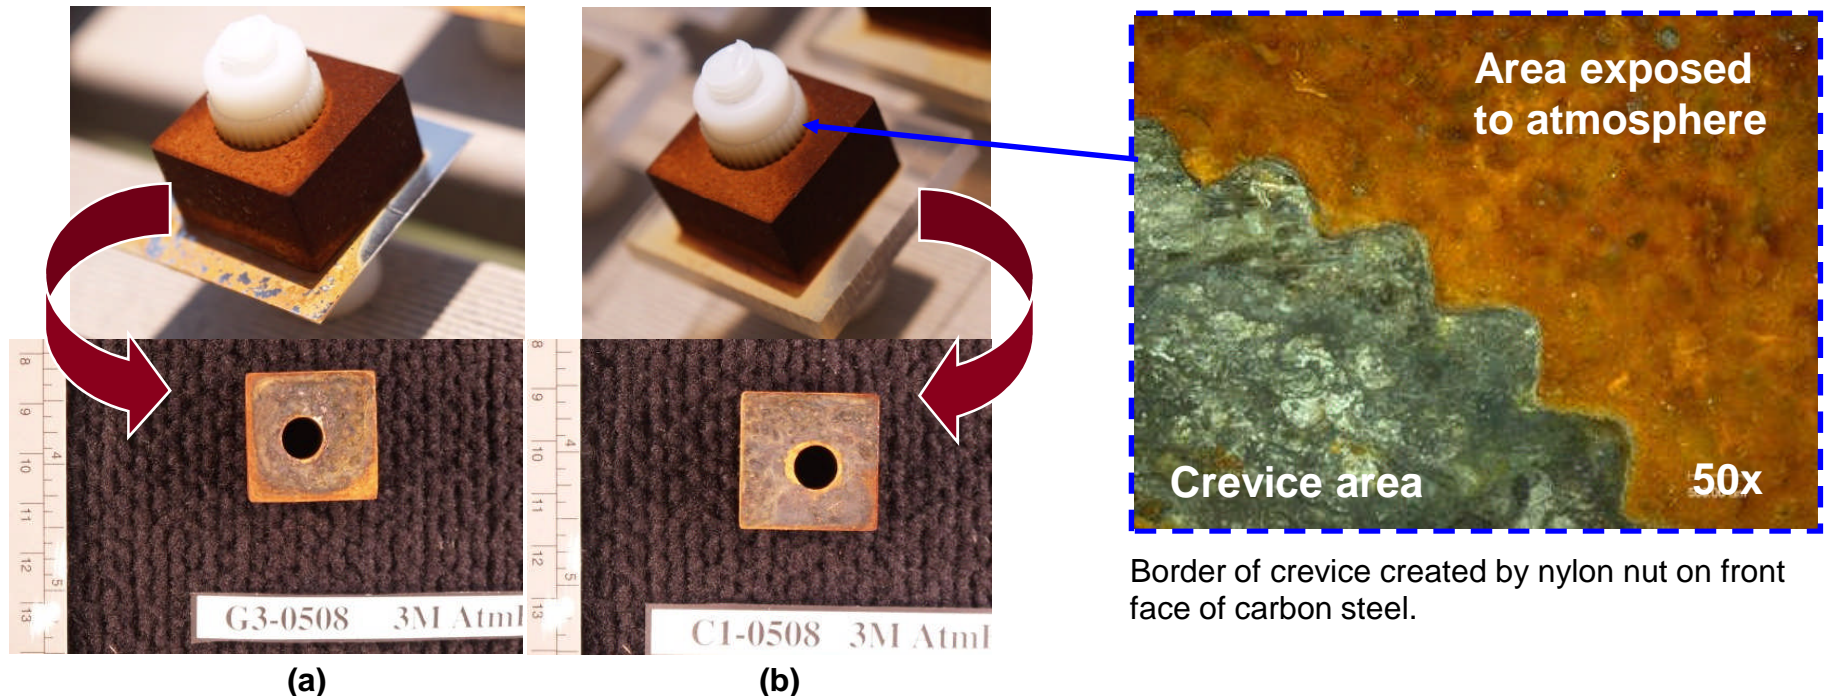
Carbon steel specimens during atmospheric exposure (a) galvanic couple (St-SS) after 3 months, and (b) control with plastic backing after 3 months

- As expected, the carbon steel specimens exhibited the most atmospheric corrosion.
- General corrosion was apparent on the surface of all carbon steel specimens after 1 week of atmospheric exposure.
- However, the corrosion was not significantly different in the coupled as compared with the uncoupled arrangement.

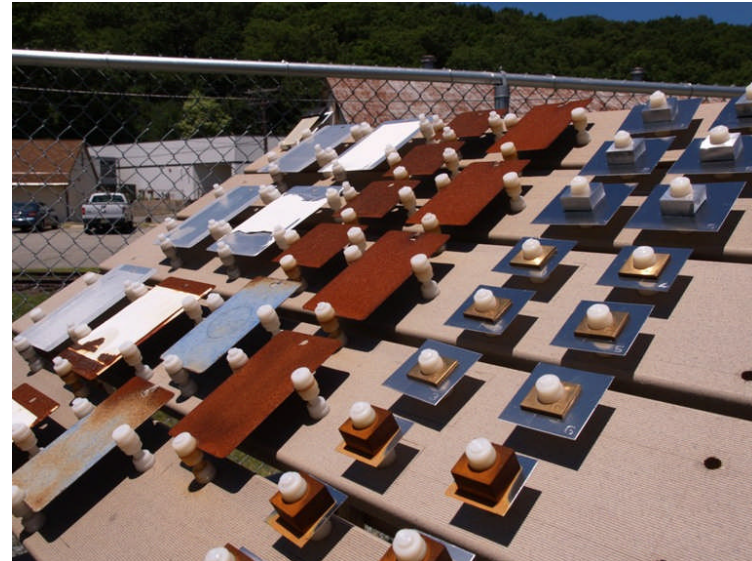
Atmospheric exposure rack at Picatinny Arsenal

- For the atmospheric exposure specimens in general, it can be stated that the effect of being coupled to stainless steel did not significantly accelerate the corrosion rate.
- More time-of-wetness and a greater exposure to corrosive agents (chloride ions, sulfur dioxide, etc.) may have provided a more noticeable difference between coupled and uncoupled specimen degradation.
- The final set of specimens will continue to be exposed and monitored over the next year.
- Weight loss will be measured upon removal of final specimens however localized corrosion such as pitting can be misleading .

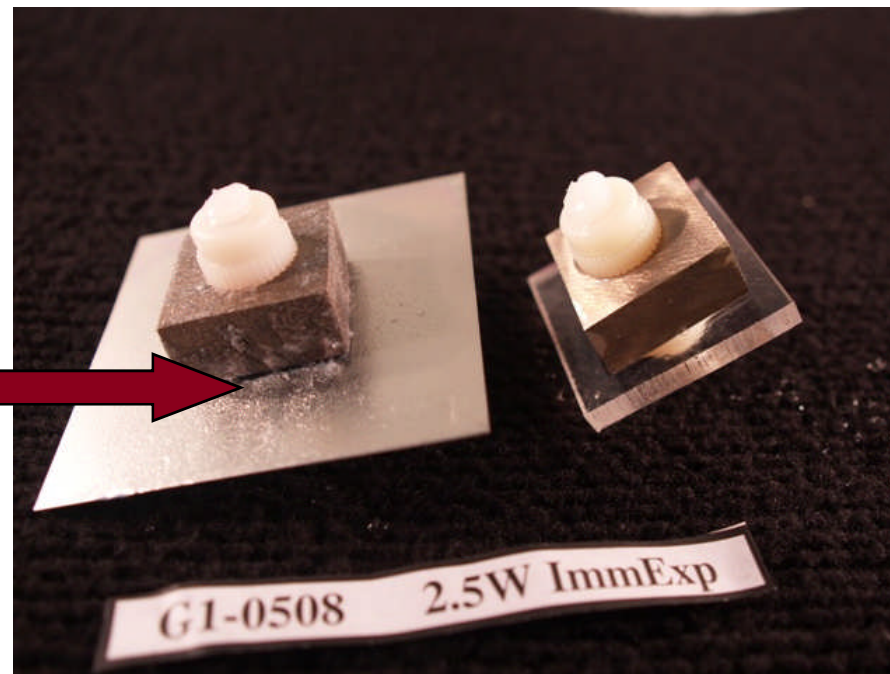
- **After 2.5 weeks of immersion** in artificial seawater, the galvanic coupled Al had a considerably large amount of white corrosion product.
- When the couples were separated for further examination, it was very clear that the galvanic couple had accelerated the Al corrosion rate.

Corrosion
product

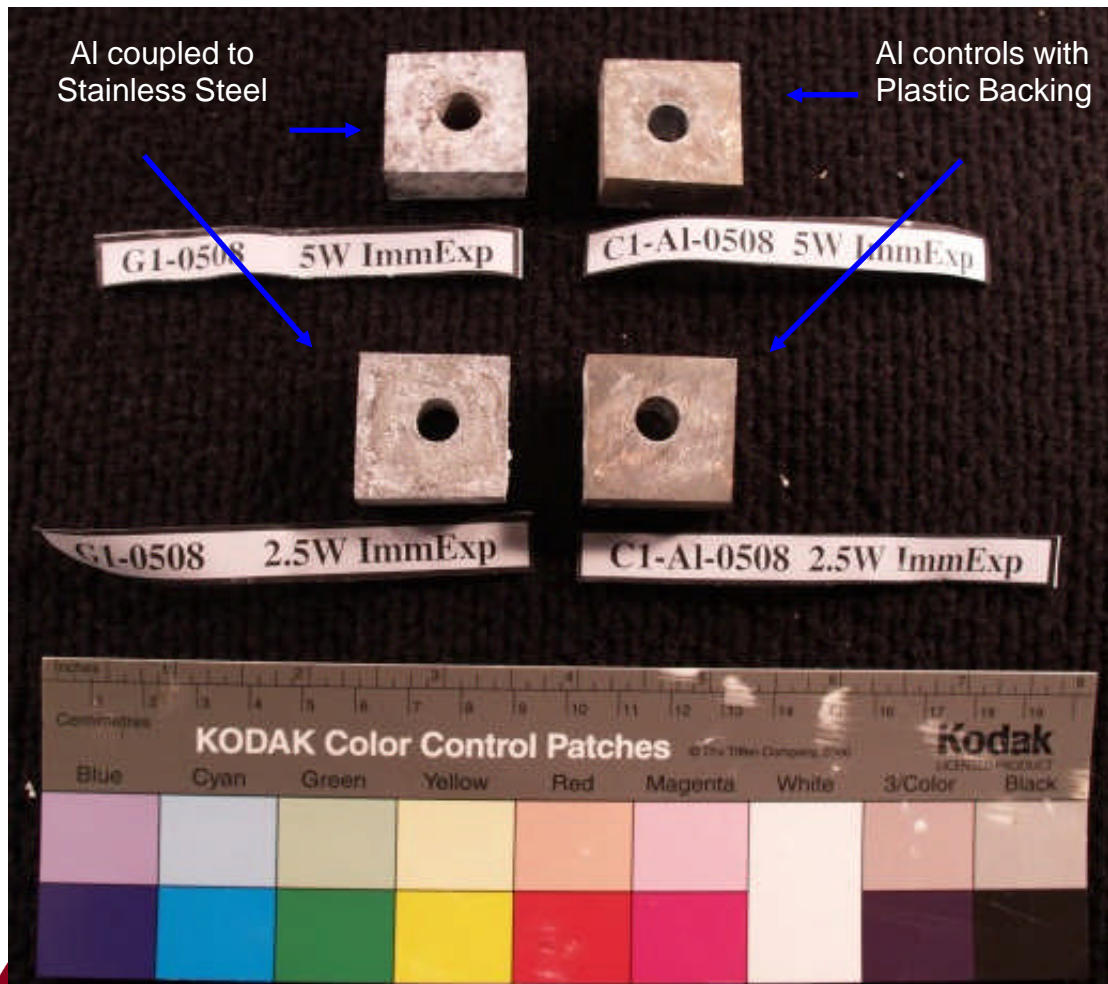
- After 5 weeks of immersion

Digital microscope images of Al specimens after 5 weeks of constant immersion in artificial seawater (a) coupled with stainless steel and (b) with plastic backing

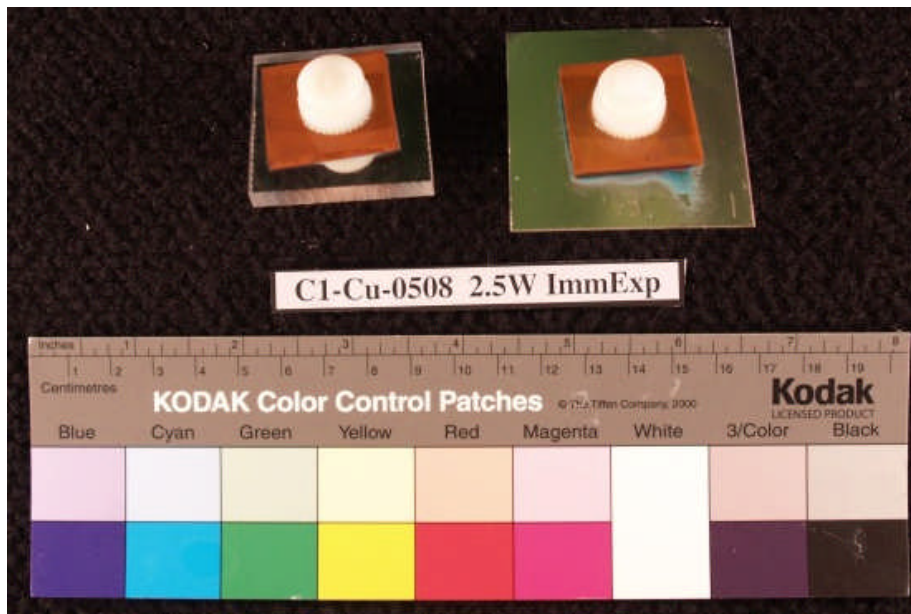
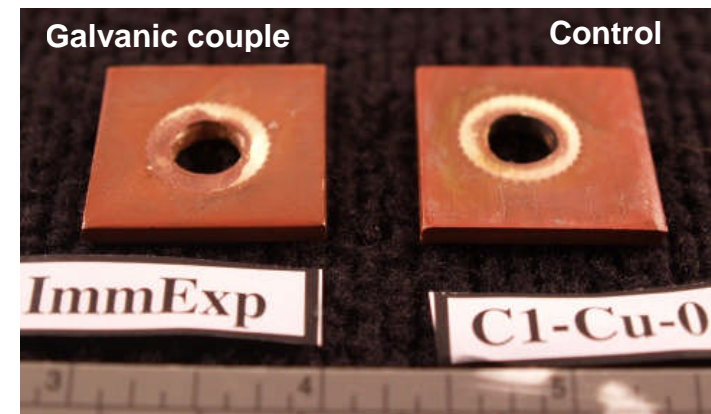
Front sides of Cu alloy specimens after being separated from coupling setups

- **After 2.5 weeks** of immersion in artificial seawater, one set of specimens was removed for inspection.
- It was already apparent that the galvanic couple Cu alloy was corroding more than the plastic-backed specimen.
- The area underneath the nylon nut is still untarnished.

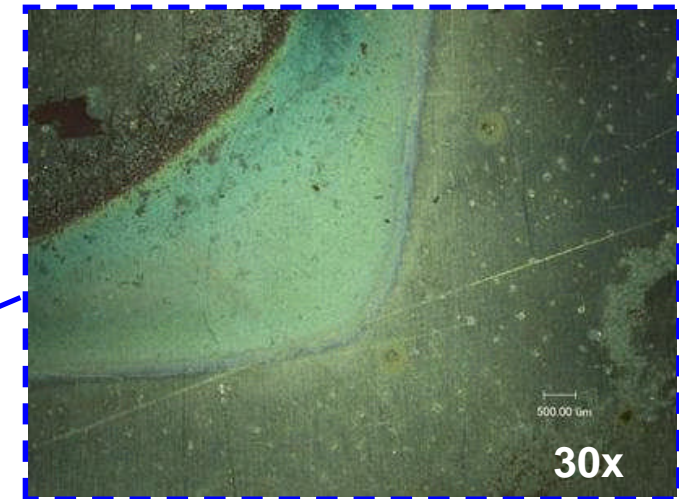
Digital microscope image of corrosion product residue from the Cu alloy on the stainless steel specimen after 5 weeks of immersion in artificial seawater.

- Analysis supported the idea that the corrosion product was from the Cu alloy (as expected).
- The Energy Dispersive X-ray Analysis (EDXA) also showed that the red material contained a large amount of Ca and S.

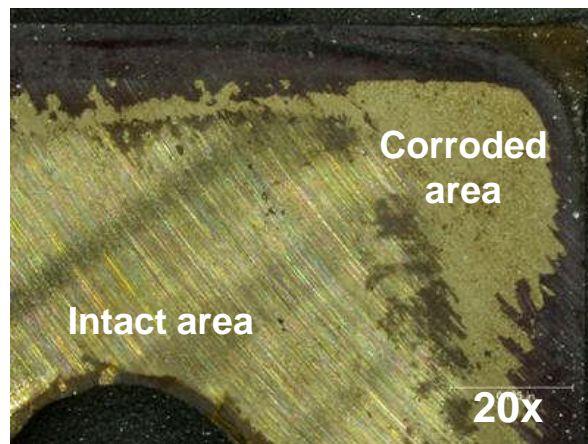
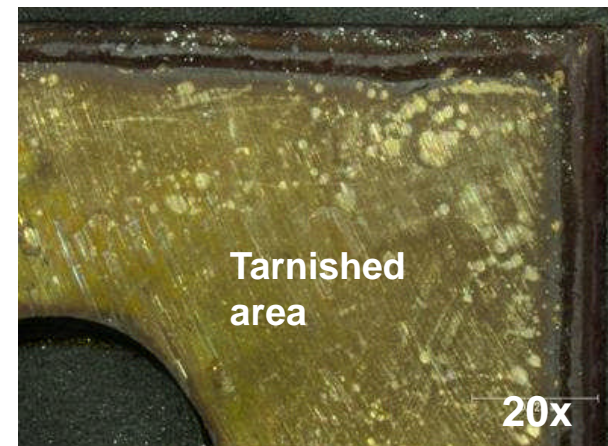
Digital microscope images of Cu alloy specimens after 5 weeks of constant immersion in artificial seawater (a) coupled with stainless steel and (b) with plastic backing.

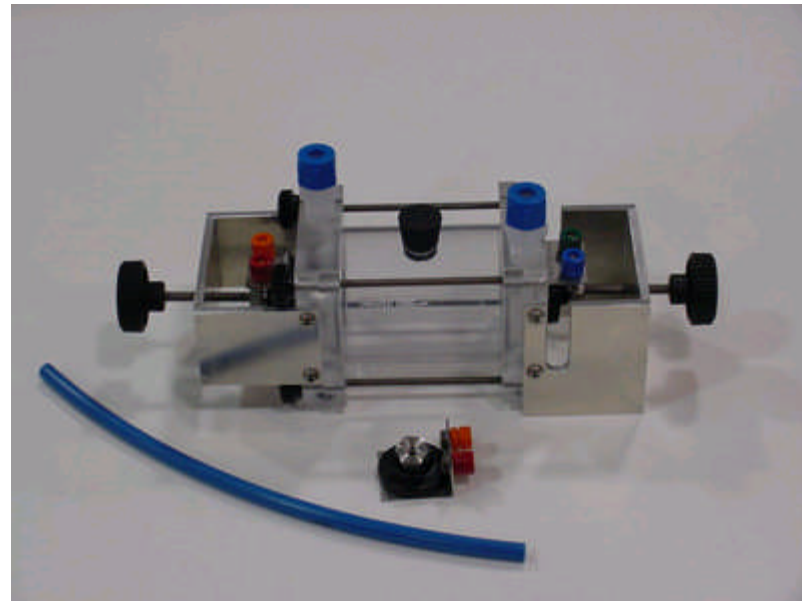
An additional test was conducted to compare the galvanic reactions of the different materials with stainless steel. In this electrochemical test, a zero resistance ammeter was used to maintain a constant potential difference of zero between the two materials of interest. The area ratios were kept equal to accommodate the test setup and the subsequent analysis.
